Manhole Inspection Summary

Manhole # S17QQ1043MH

Insp Date: **6/27/07 11:46 AM**

Location Address: **4890 STRAWFLOWER LN**

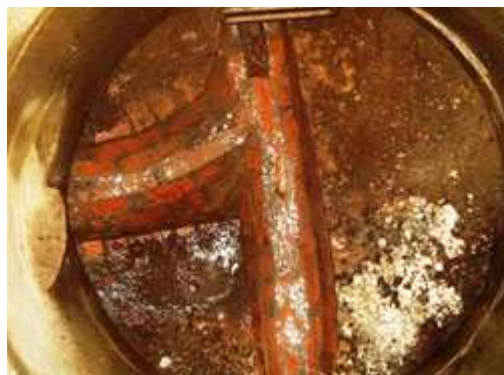
Top View

Infiltration: ☐ None ☒ **Joint** ☐ Cracks ☐ Mortar ☐ Roots ☐ Wall

☒ **Debris** (not Condition related)

Corbel infiltration. Bench debris.

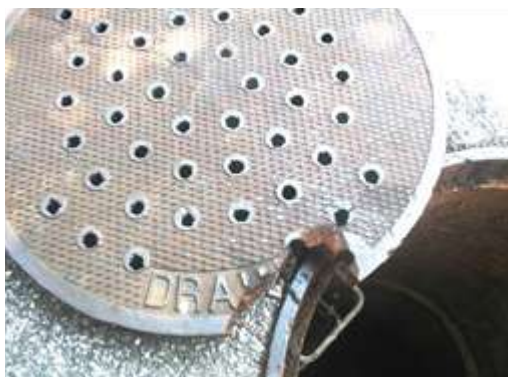
Defect

Condition: **Broken**

☒ **Leaks**

Frame leaks. Broken Storm lid.

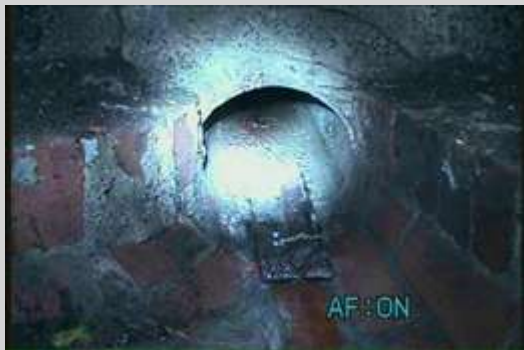
8 in. Circular Gravity Sewer Pipe Out @ 12 O'Clock

Deposits: ☐ None ☐ Mud ☐ Sludge ☐ Debris ☒ Grease

Silt Depth: **0** (in.) Deposits Extent: **Light**

Infiltration: **Evidence** Pipe Seal Cond: **Unknown**

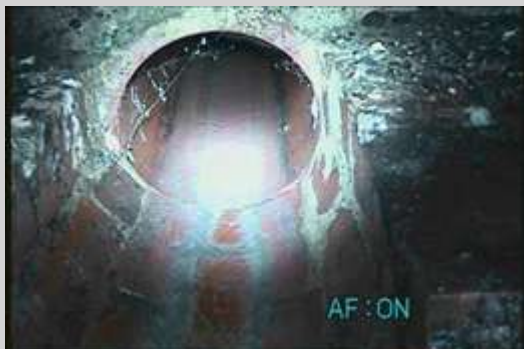
8 in. Circular Gravity Sewer Pipe In @ 6 O'Clock

Infiltration: **Evidence** Pipe Seal Cond: **Unknown**
